## T34 World News

2012 Edition #14

### CONTENTS:

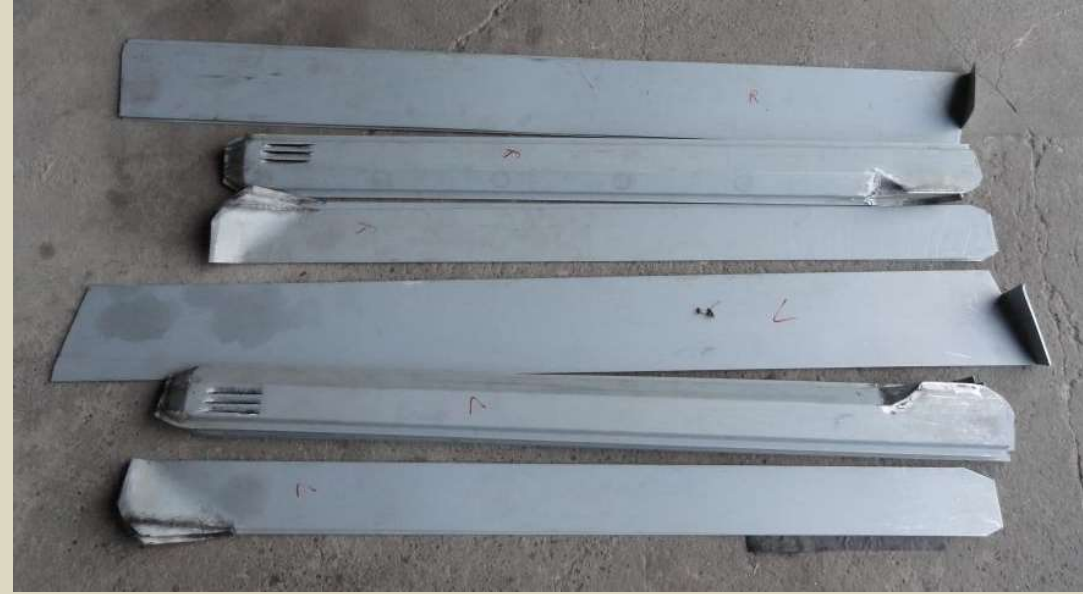
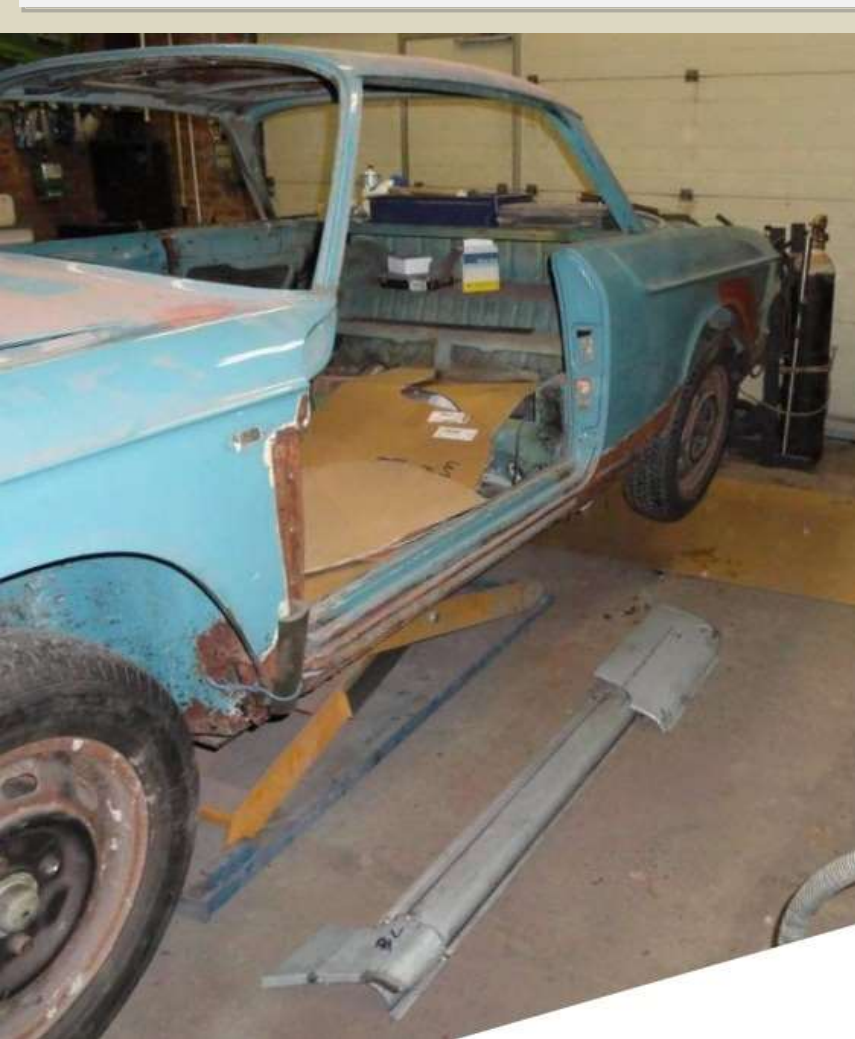
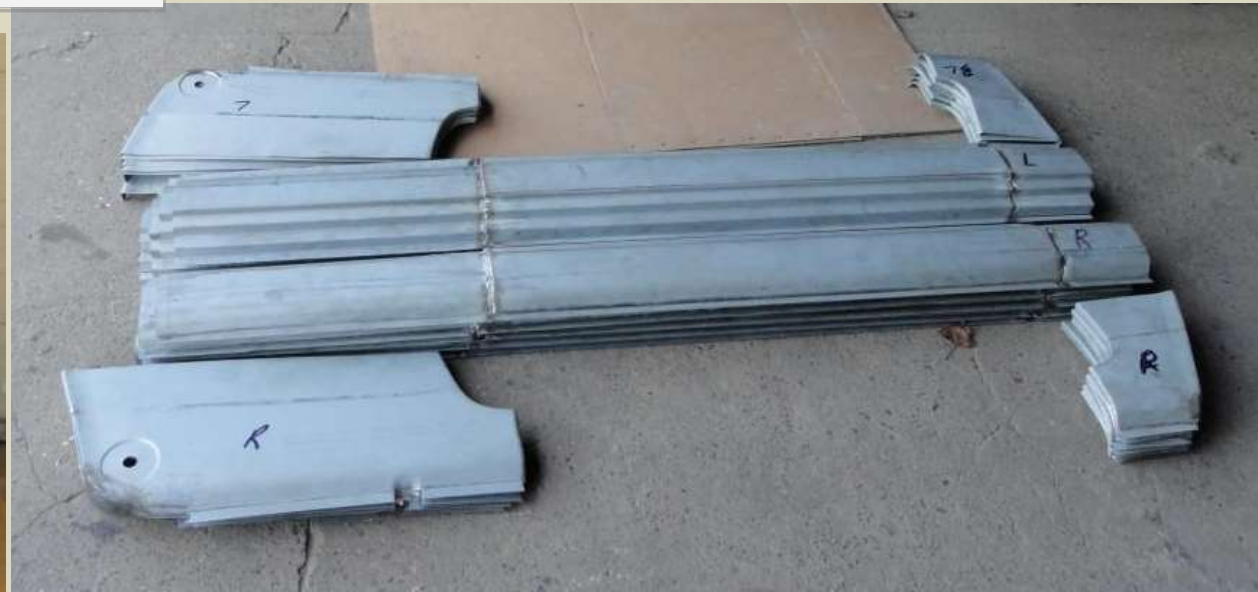
Jurgen Magdelyns in Belgium is now offering the repair panels for the rocker panels & the inner heater channel metal as well! These panels are made from 1mm galvanized sheet metal.

Chris Forget's 1968 (featured in a Resto Update article) was recently fitted with these replacement sheet metal panels. Jurgen Magdelyns has been working on the metal repairs for Chris.

Chris was very fortunate to have T34-expert **Jurgen Magdelyns** agree to help him repair the heavy bodywork. Jurgen has reproduced the rocker panels & the inner heater channels, one of the major jobs ahead of them. And he was lucky to have bought a nose section in good condition from **Carsten Klein** in Germany.

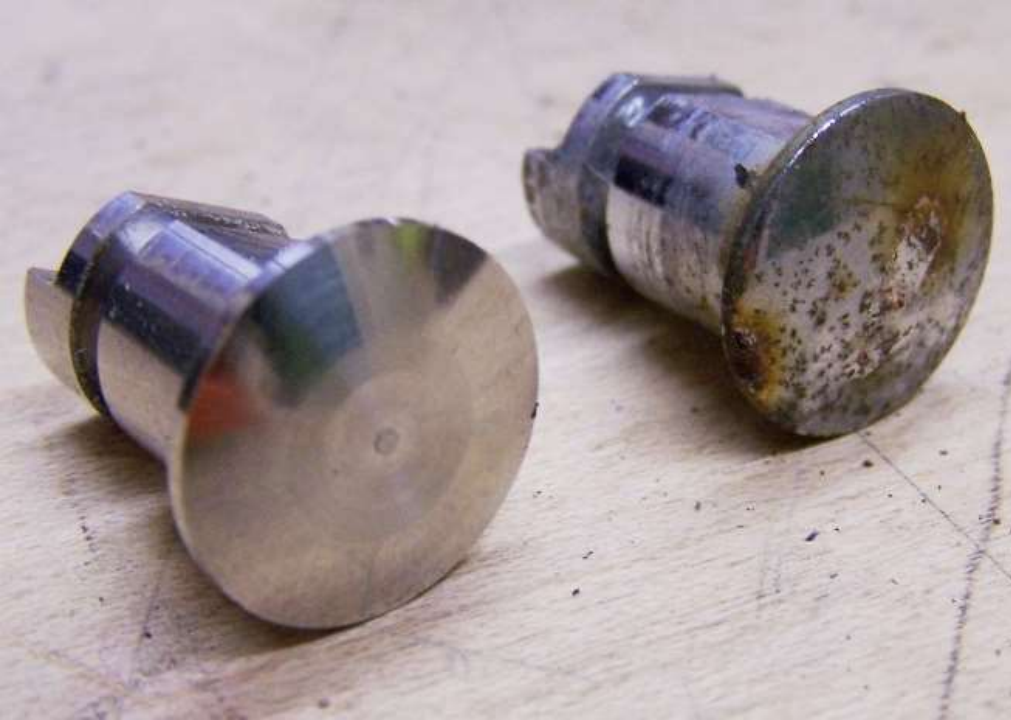
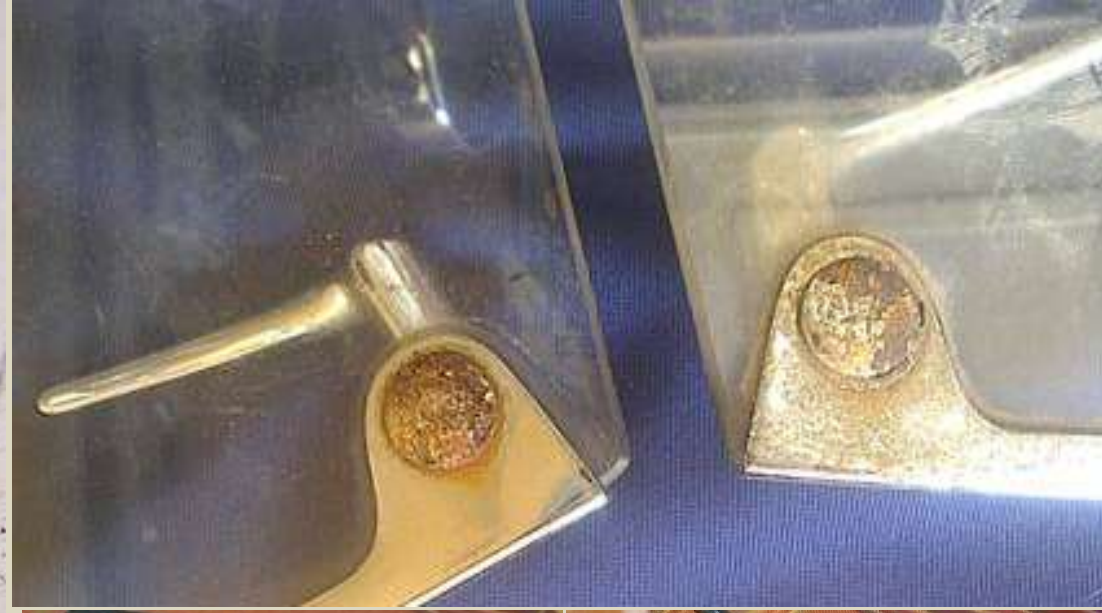
One of the most common rust-prone parts on T34s is the **chrome bolt for the vent frame windows**. The photos above show typical vent bolts. The good news is that we now have a reproduction source for these done in stainless steel in Germany by our German rep **Michael Moesinger**! Although this part is not chromed, it is an excellent replacement to the rusty original ones. Finding an NOS vent window can be extremely difficult and often costs over \$300.

The replacement of this bolt is quick & easy with one tool. The small pin must be pushed-out with a nail or thin punch. Then you can wiggle the inner handle to remove it. The bolt is then easily pulled-off. It's a good idea to polish the vent window frame chrome at this time before reassembling the bolt & handle. The shims (to keep tension on the handle) should not be forgotten during the bolt installation. And finally the little pin can be pushed back inside the handle to finish the job.

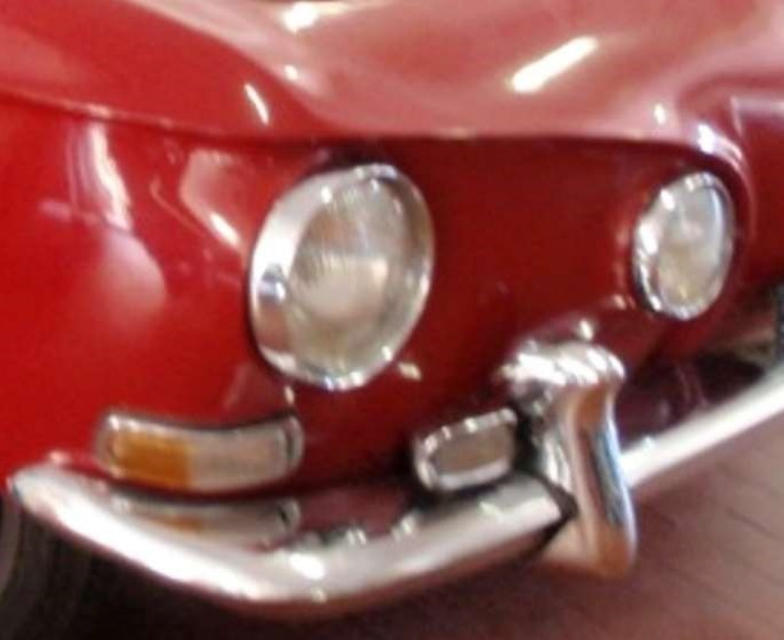
You can see the extremely rare two-toned front signal lenses fitted to Italian T34s, amber on the rear half & clear on the front half.

An extra pair of fog lights were added to the front bumper which match the added set of reverse lights in the rear.

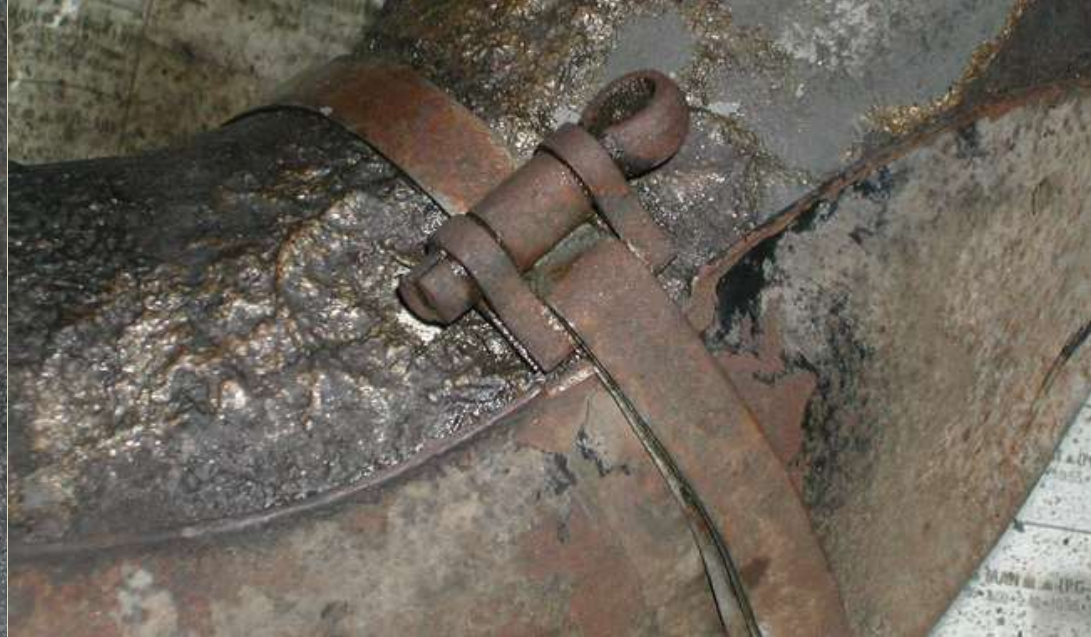
My 1962s heat exchangers were in good condition after 44 years of use with grease & grime protecting them from rust. The “before” photo (above) shows the tiny early (1962-63 only) tin pieces on the ground along with the lower cooling tins still attached.

The heat exchangers had collected a lot of debris blown in from the fan housing over time. I pulled out a lot of junk including cardboard, feathers, insulation from the engine trapdoor, & even a metal intake manifold gasket. Next I had to strip the exchangers down and degrease them. And I made note of the way the stone shields were attached before taking them off (upper right).

Early heat exchangers had sprayed-on insulation (the more familiar asbestos wrap was introduced in April 1963), but as the grease came off I was surprised to see that what was left of it was a metallic gold color. I'm sure it's mostly asbestos and the dust from this stuff is not something you'd want to be breathing.

I did some research on substitutes for the coating and settled on Lizard Skin ([www.lizardskin.com](http://www.lizardskin.com)) ceramic insulation. It's not cheap but it has properties that make it a good choice for the job: good heat & sound insulation, withstands temperatures to 500°F, water based & non-toxic. I applied it with a brush over ISP West's ceramic coating, recreating the original texture, and then gave it several coats of engine enamel.

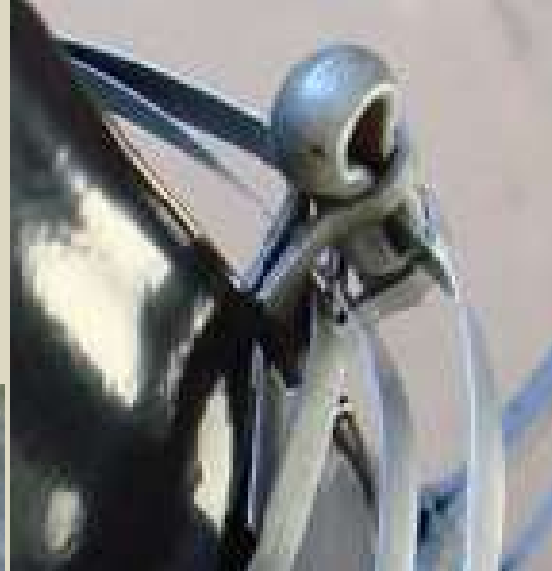
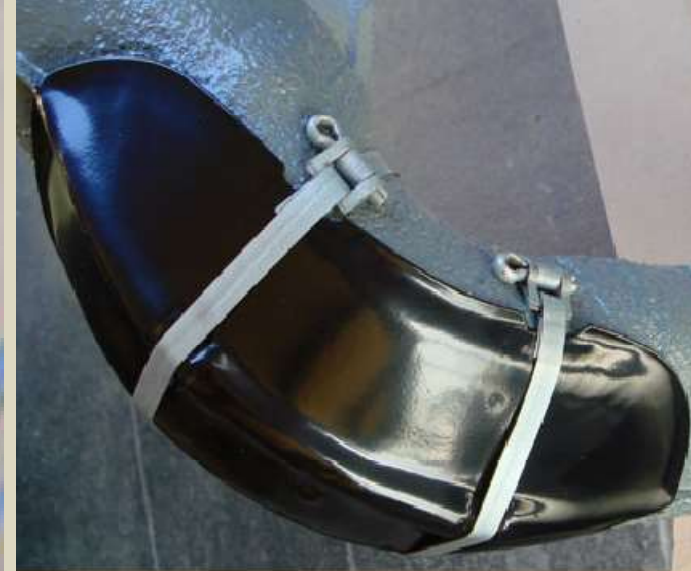
After getting the metal stone shields back from the powder-coaters it was time to install them with the metal straps. I considered buying bulk strapping from a source like McMaster-Carr (a highly recommended source for industrial supplies), but NOS straps from BerT3 in Belgium cost only a little more. It's always a good idea to use NOS parts whenever practical!

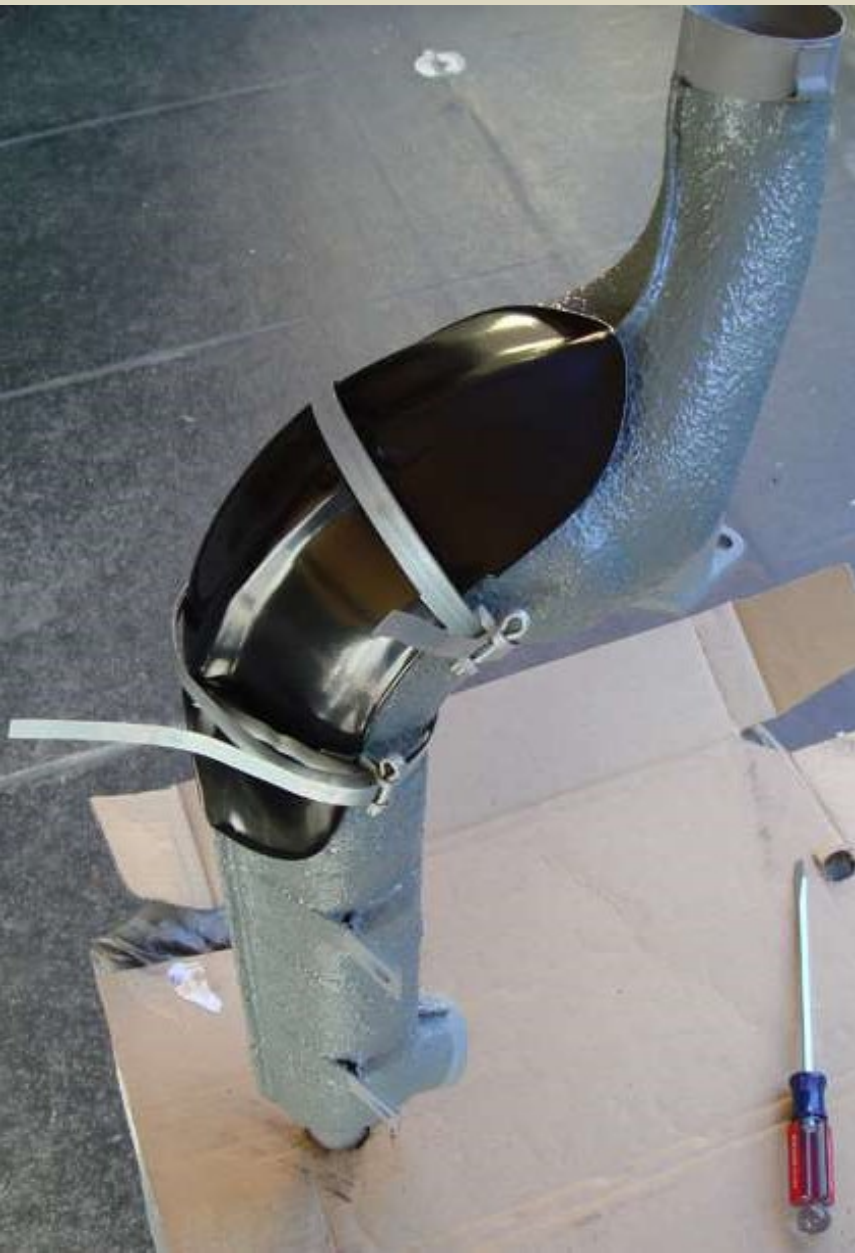
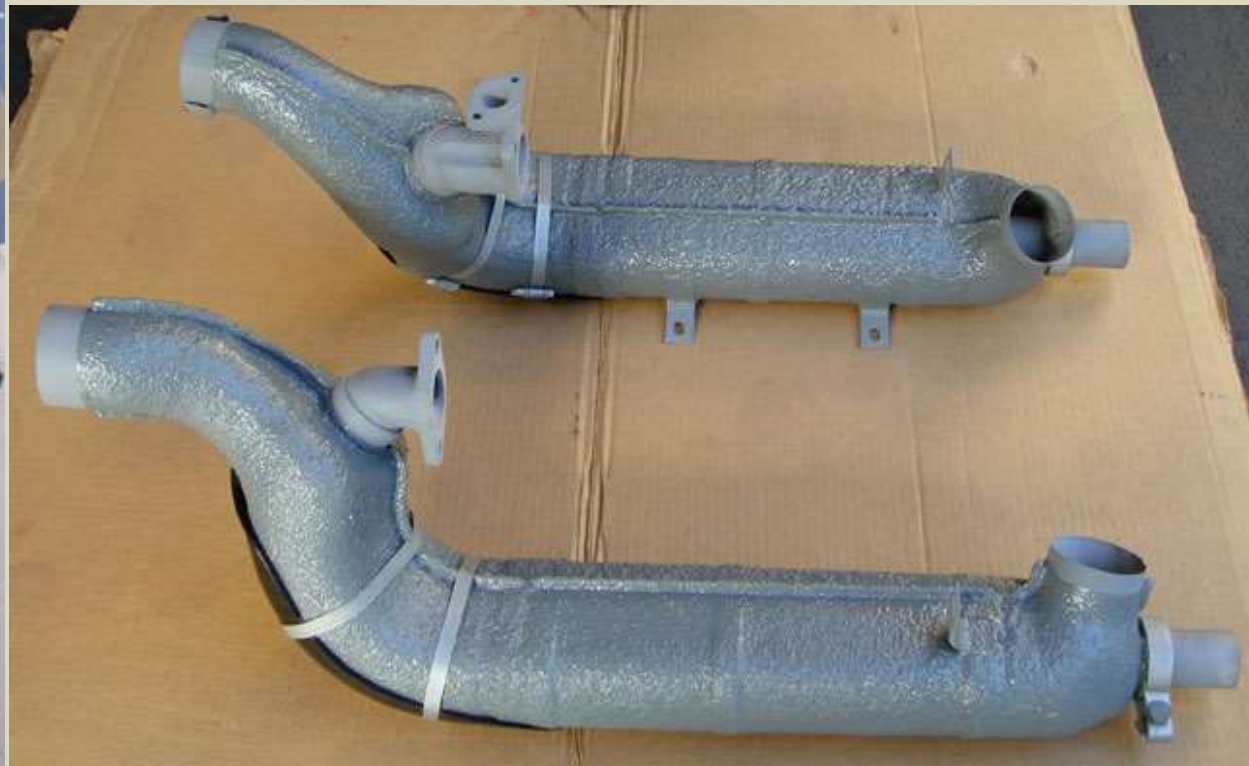
Position the shield & straps loosely. Originally VW had the clamps on the inboard sides. The strap wraps around the heat exchanger once, threads through the rectangular hole on the clamp, then wraps around a second time and threads through the cotter key. Pull in the slack and then trim off some of the excess strapping. Then tighten the key with a screwdriver a half-turn at a time, stopping to adjust the strap and reposition as necessary as you go. Turned out very nice!

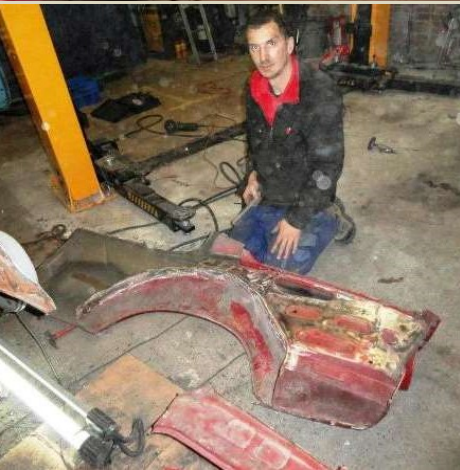
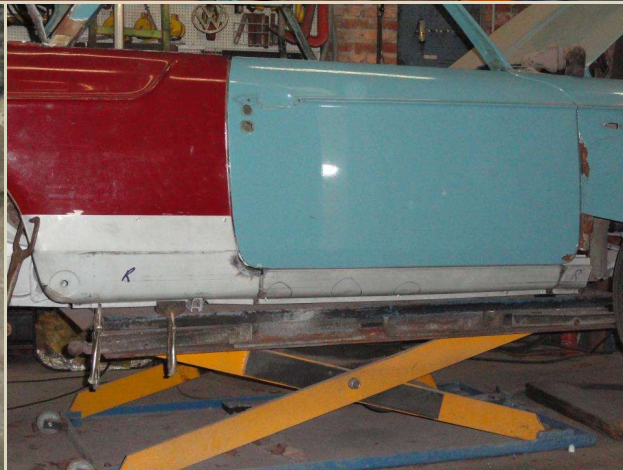
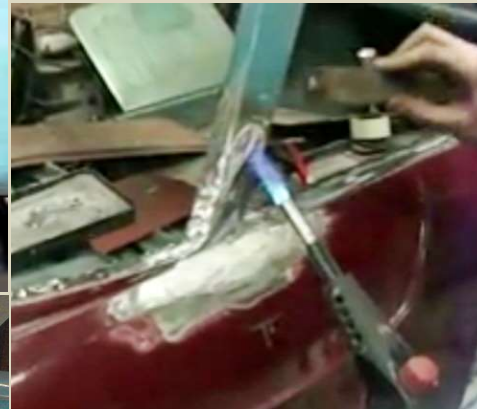
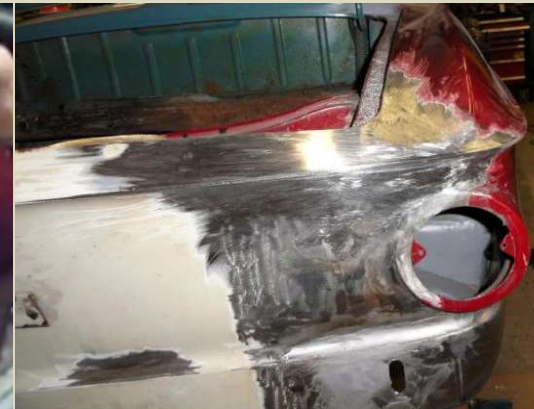
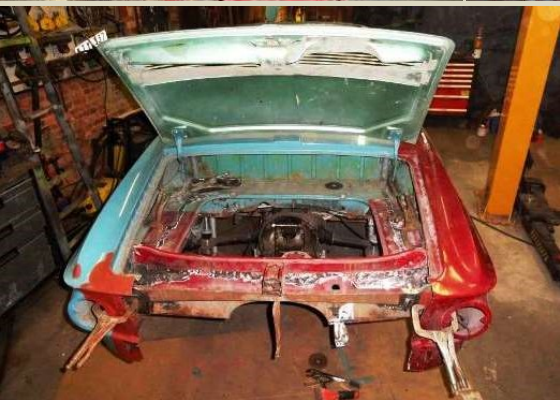
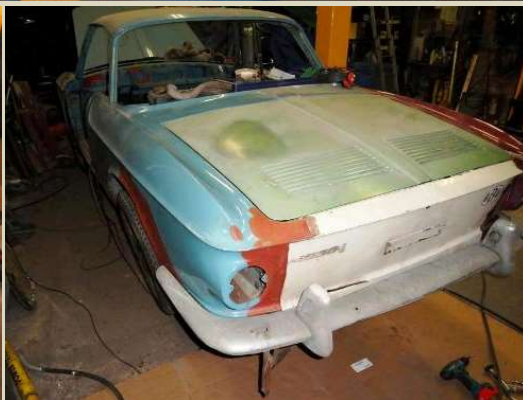
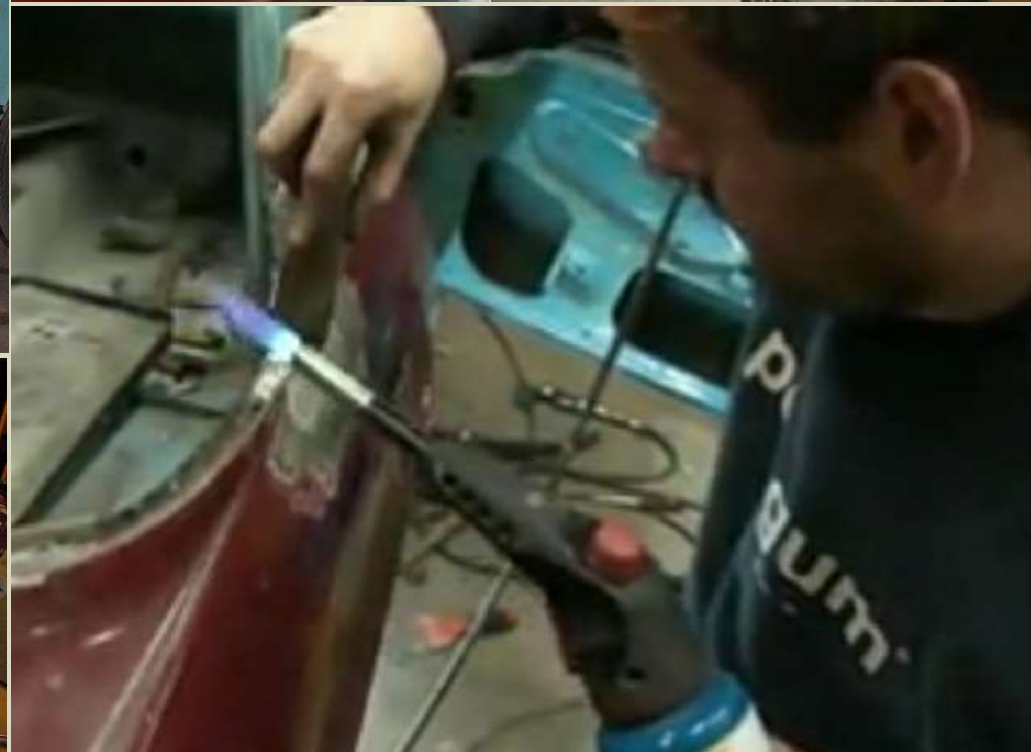
Jurgen has spent January working the body in his shop. The rear panel was removed and the replacement one welded into place. Then the right-rear fender was replaced with a good original red one. And the rocker panels were replaced with Jurgen's repros. Chris even got his hands dirty with the leading process.

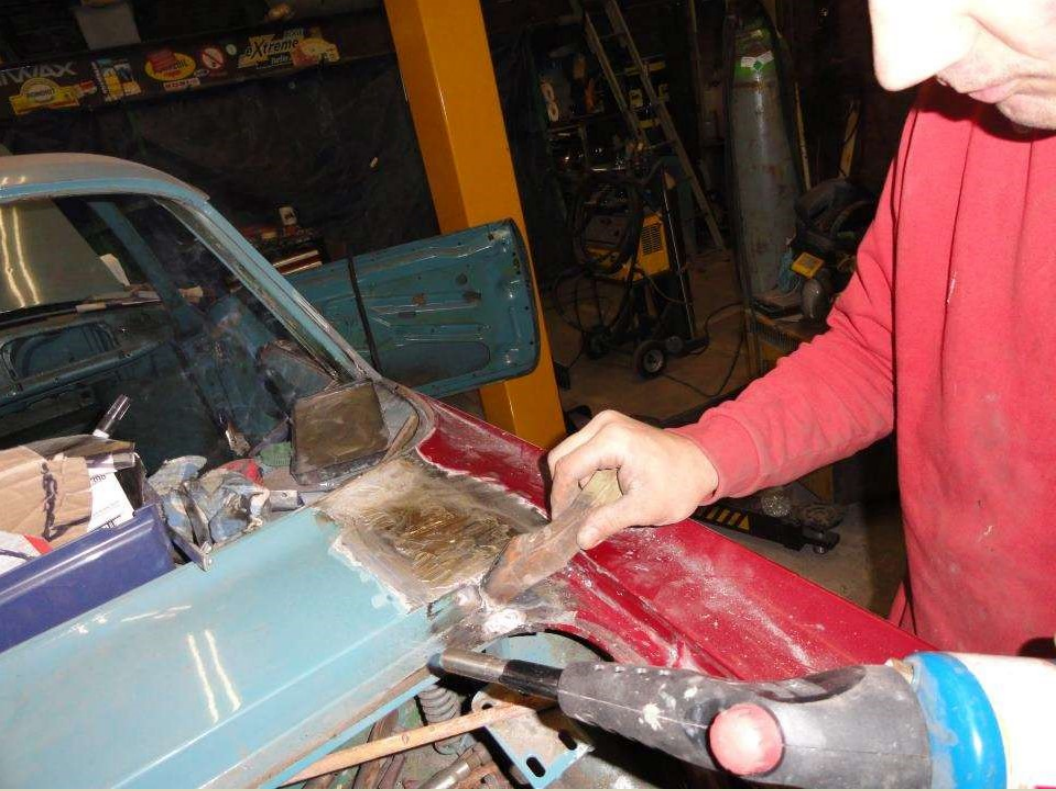
You can see the left-rear fender metalwork in bare-metal form after the wheel arch was welded into place and a hand-formed lower rear corner section was created by Jurgen. The lower-left photo shows Chris drilling-out the weld spots along the left rocker panel area.

When the massive amount of welding has been finished by Jurgen, the T34 will be returned to Chris' garage where he plans to grind out the welding in final preparation prior to painting. When that work has been finished he will strip the remaining original paint and the body will be fully sandblasted and epoxy coated so rust will never again be a problem with this 1968. The final body preparation & painting Chris will handle himself, as in another life he worked in a body shop.

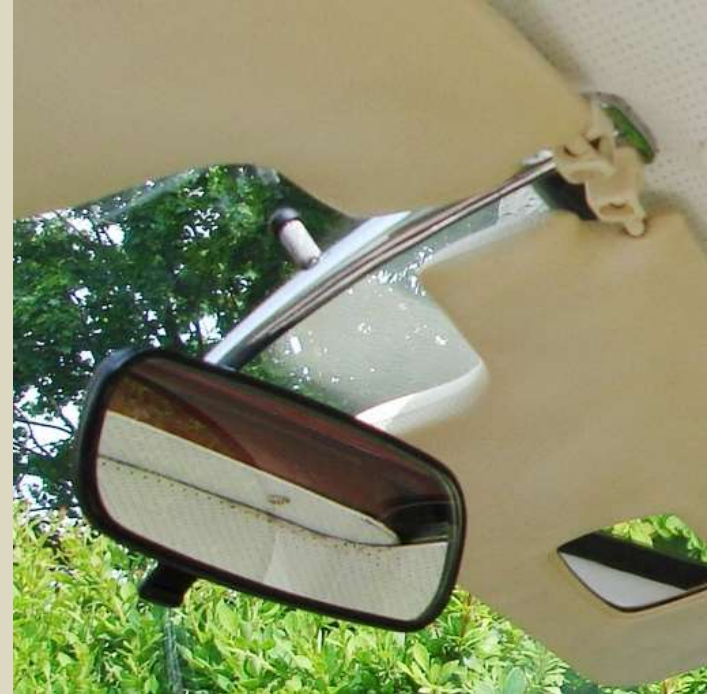
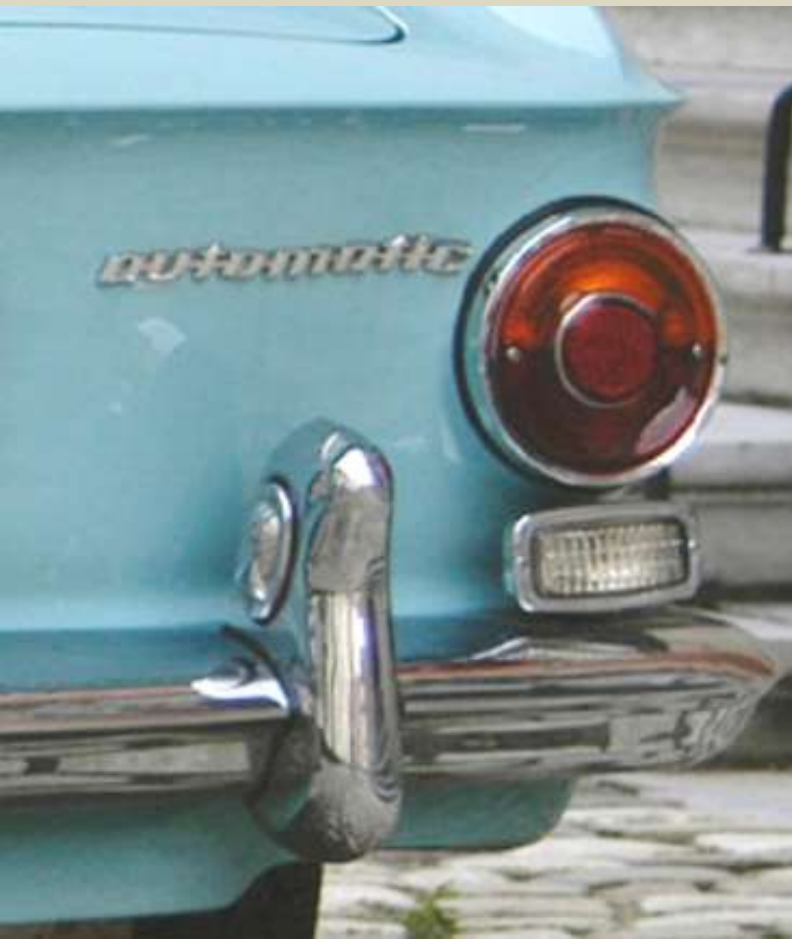
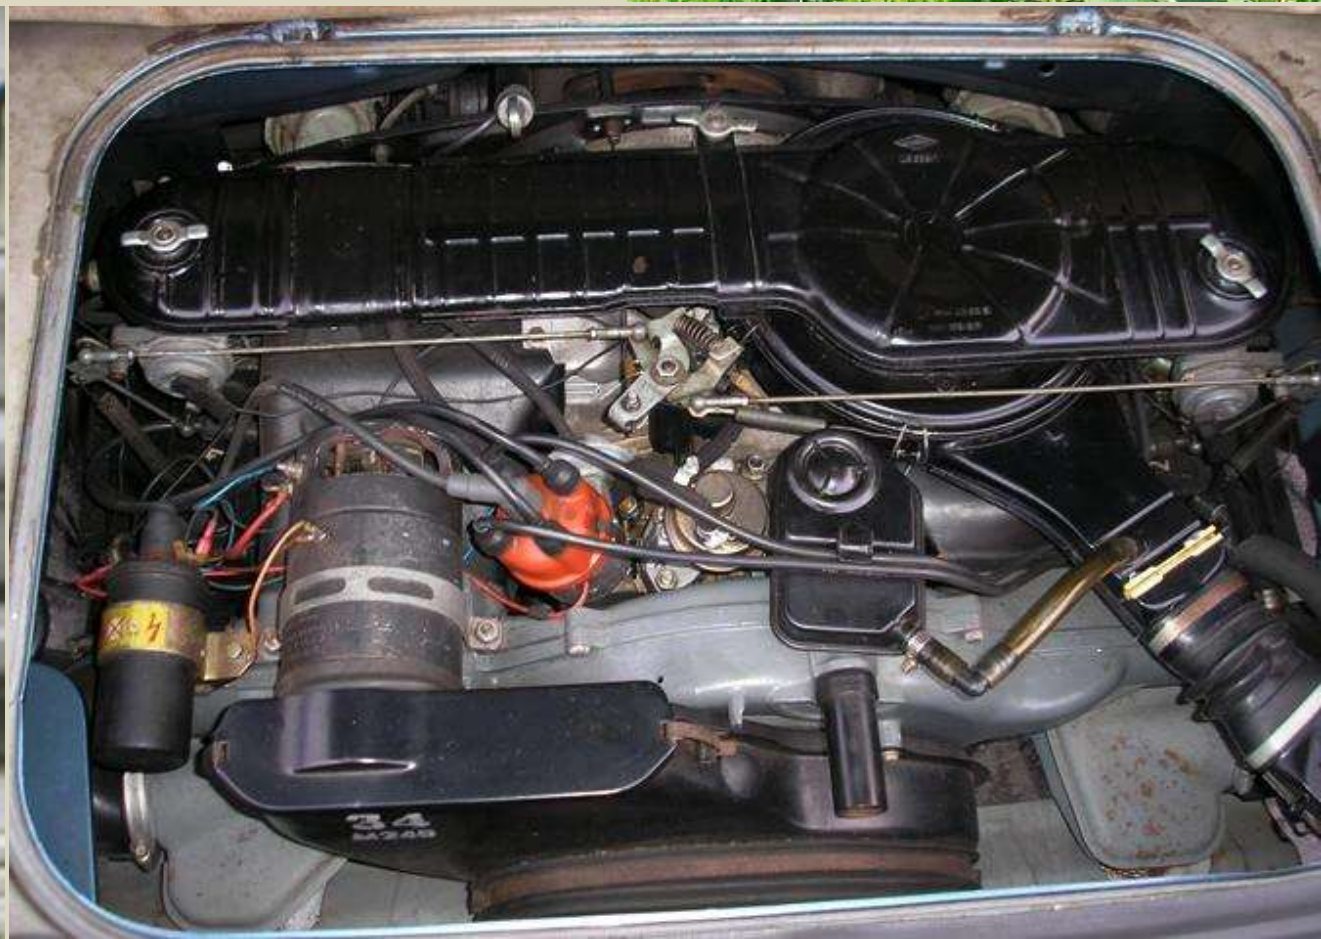
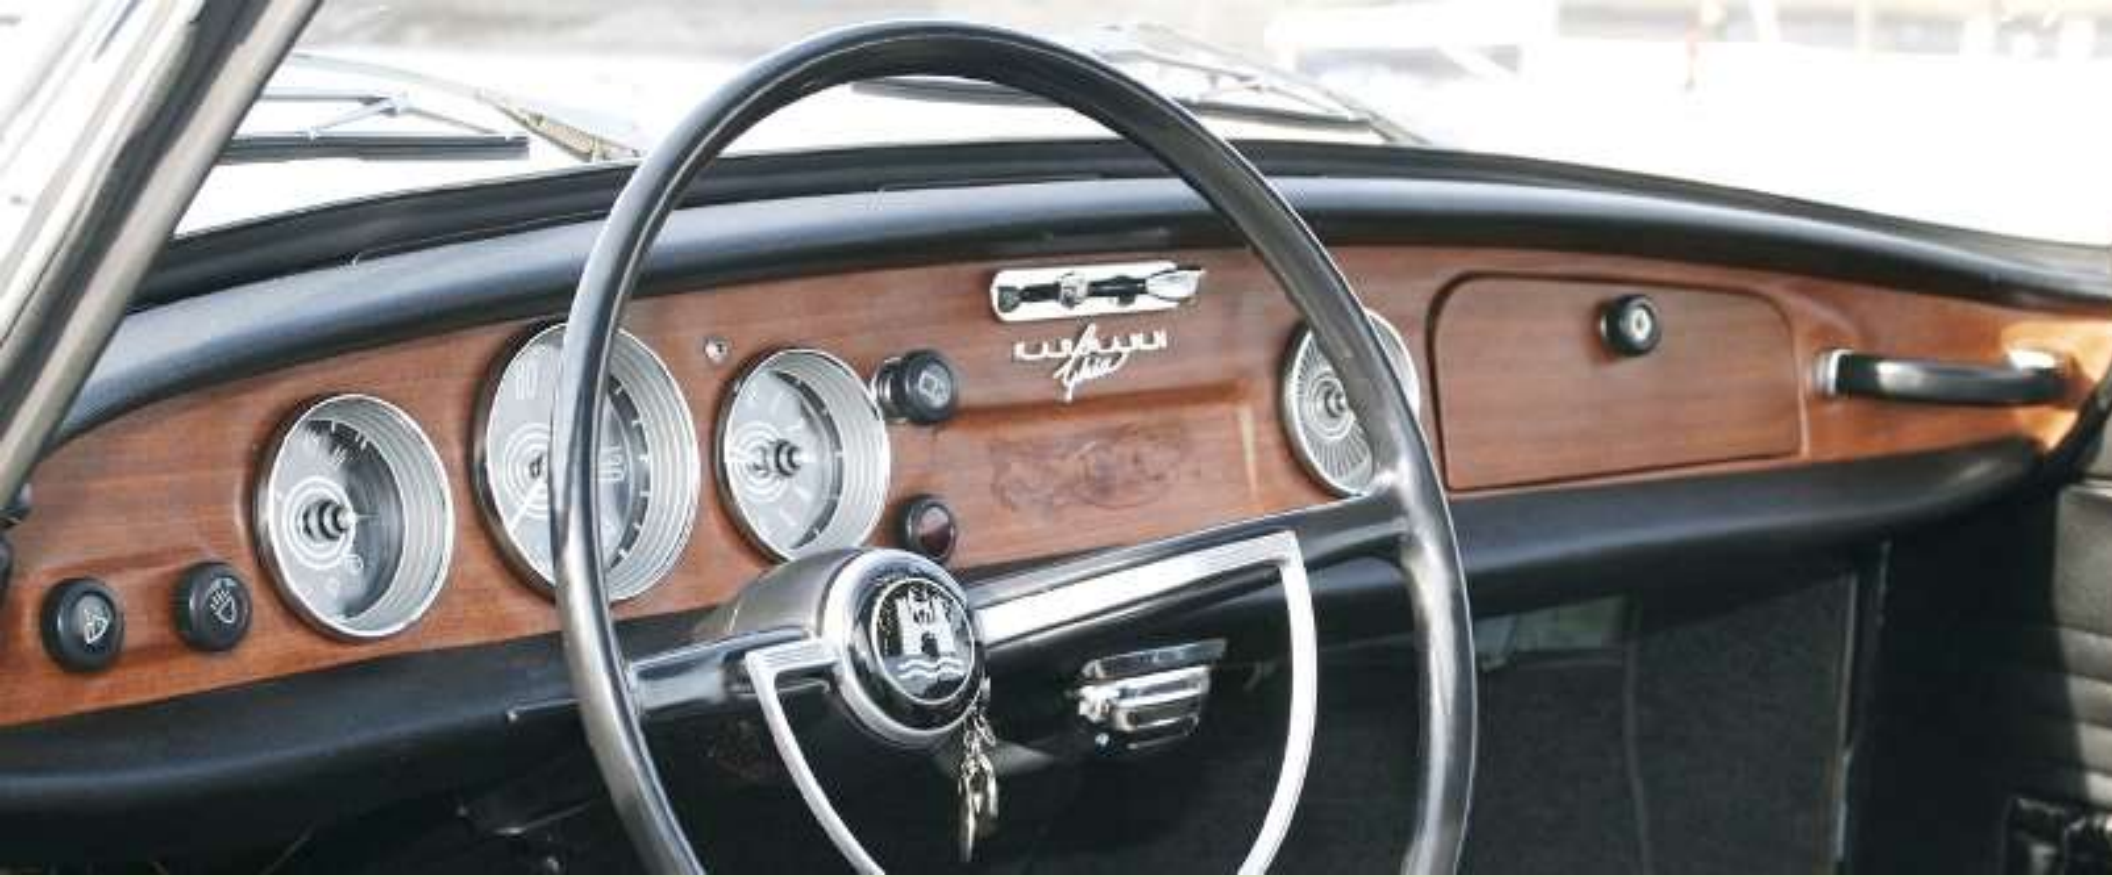
Strangely, at the very end of production the rear view mirror was changed to include an anti-vibration stem that connected the mirror arm to the windshield, buffered by a rubber knob.

In the engine compartment, mid-way through the 1969 production the rear engine hangar was discontinued from the engine trapdoor opening metal rim, yet the black metal tube for supporting the engine hangar was left in-place.

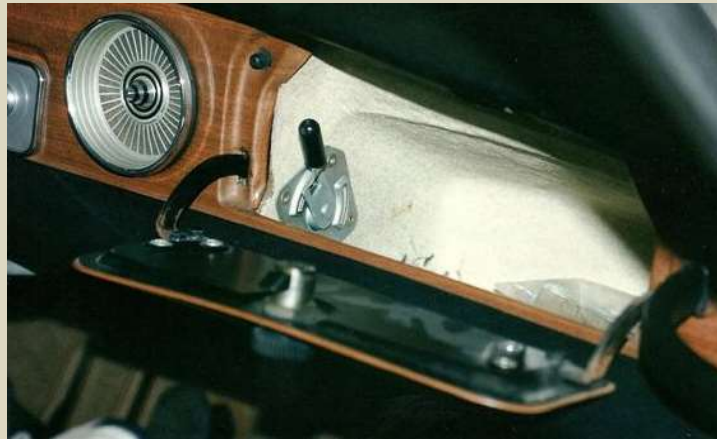
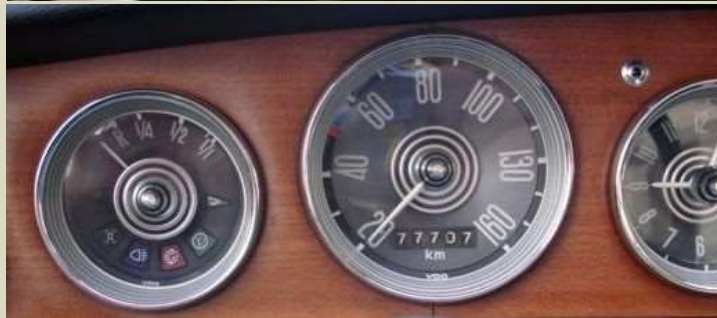
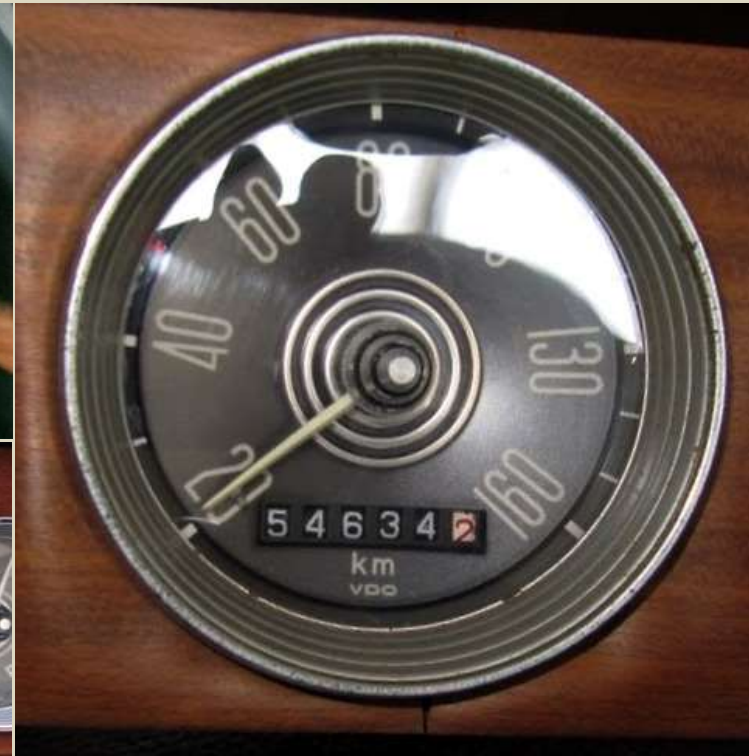
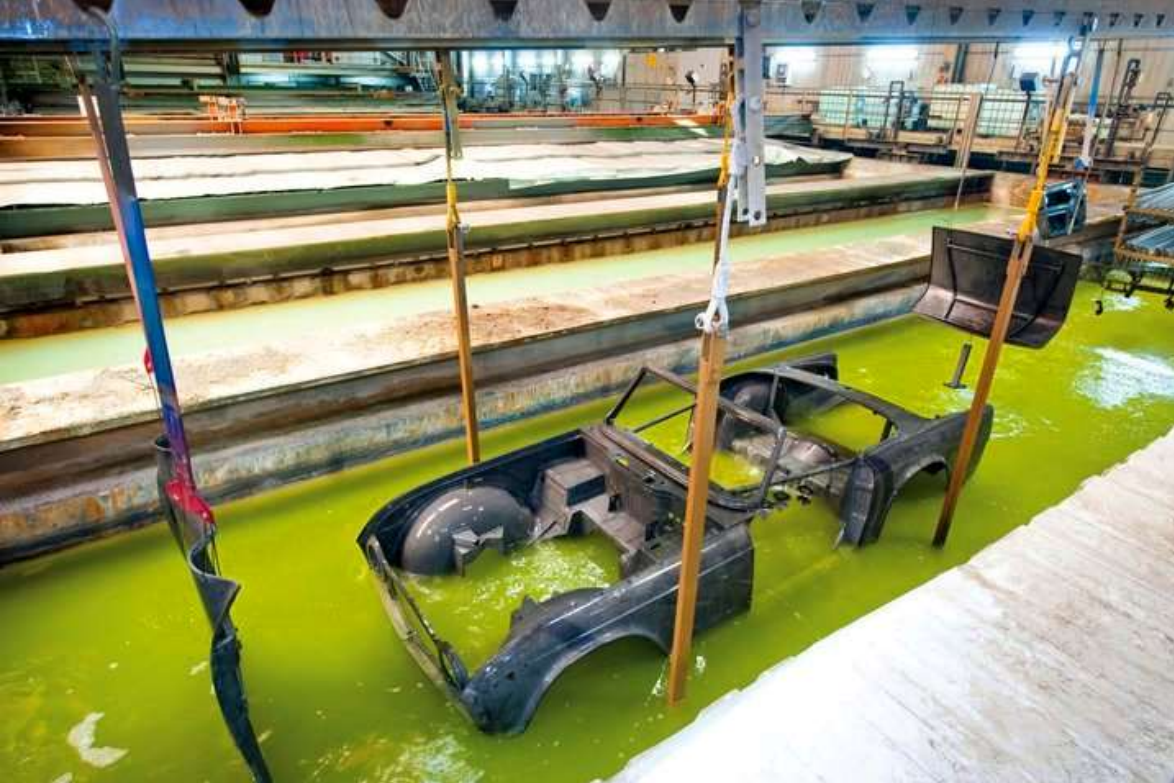
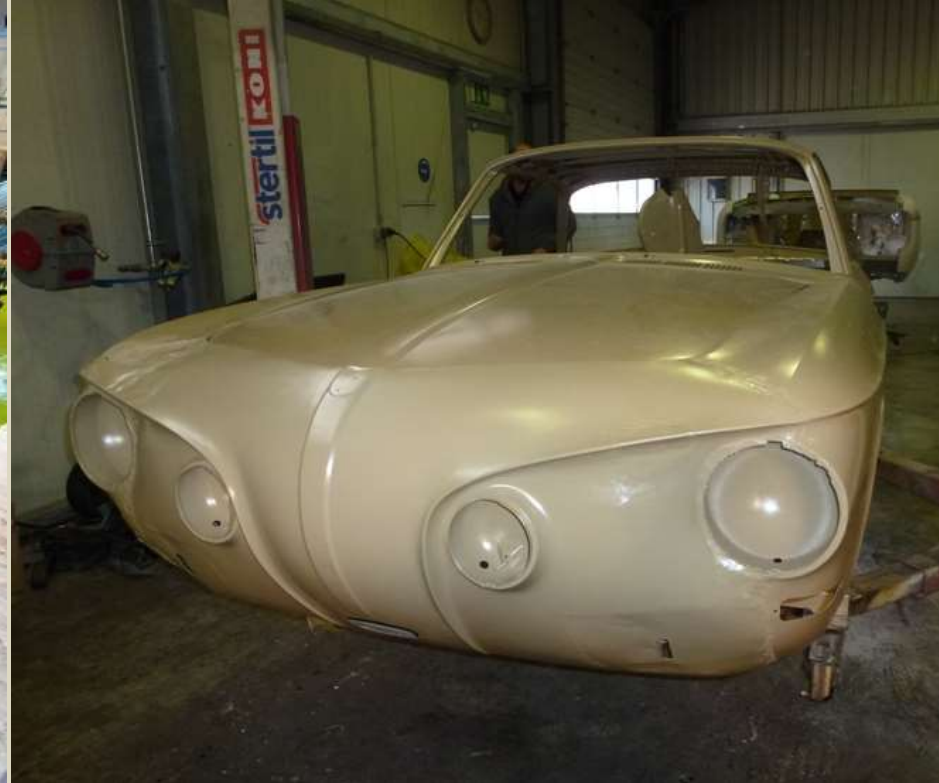
You can see the icons in the fuel gauge warning lights (below). A late-year production change was seen in the odometer, changing from the standard 5-digit version to a new 6-digit featuring a red tenth's digit.

Another mid-year change was the front hood pull knob. The first half of 1969 production had the pull knob & cable located under the dash on the left side. But the second half of production featured a new design integrated into the glovebox area. This design proved to be a poor one, as the weak paper-fiber glovebox could not support the constant pressure of the hood release lever, breaking the glovebox.

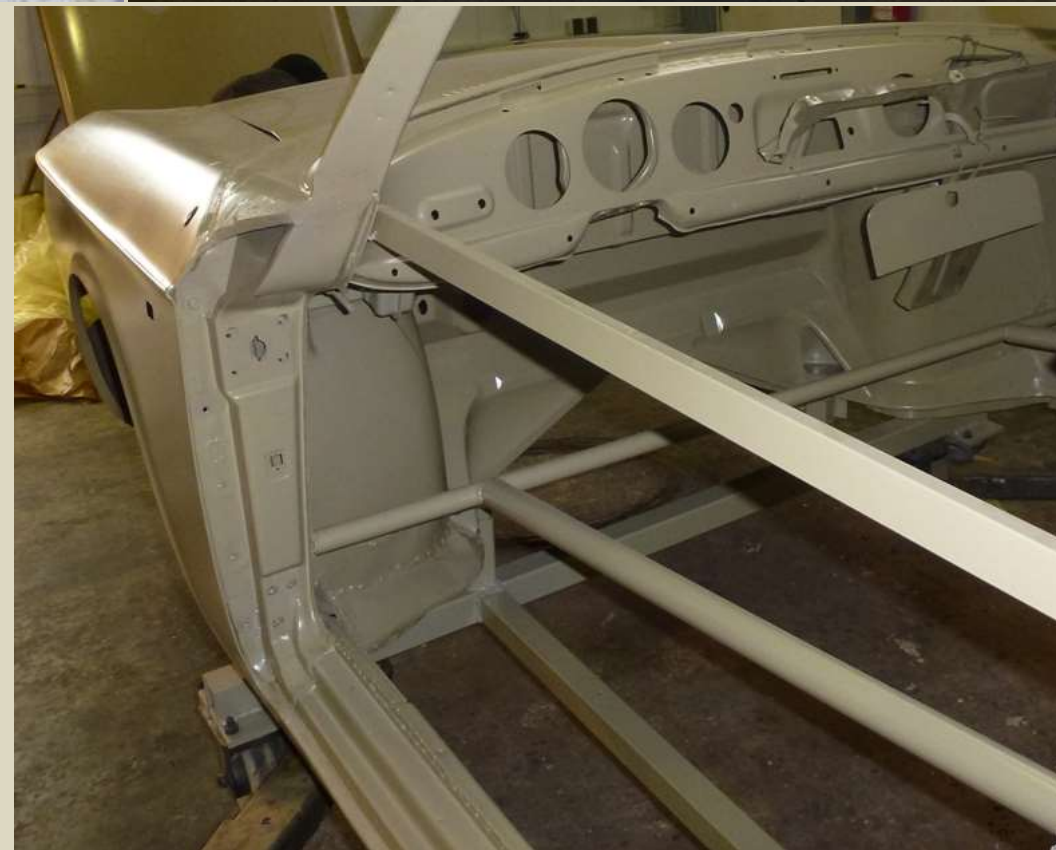
“The major welding has been completed on my 1966 T34 and the body now needed to be dipped to remove the rust. After welding, the biggest issue is one of corrosion protection. To avoid any rust developing after the restoration was completed I decided to have the body completely submerged in a three-part process. The first dip is to remove the paint. Then we de-rusted the body in a second acid bath. In this process all of the voids which can't be cleaned manually are taken care of. Then the body is submerged in the third bath which coats it with a protective layer of Cathodic electrophoretic paint. This gets into all of the cavities and protects the body against future corrosion. The photo above is of the initial dipping (showing a Triumph) but I only have photos after the Cathodic electrophoretic paint because the company didn't allow photos in the other dipping rooms. The tin (which joins the steel panels) gets stripped-off after the second bath, so you can see all of the little pin holes. So now we have now small holes in the front which must be welded again, but this is a small amount of work and not a big problem.
