## T34 World News

2012 Edition #14

### CONTENTS:

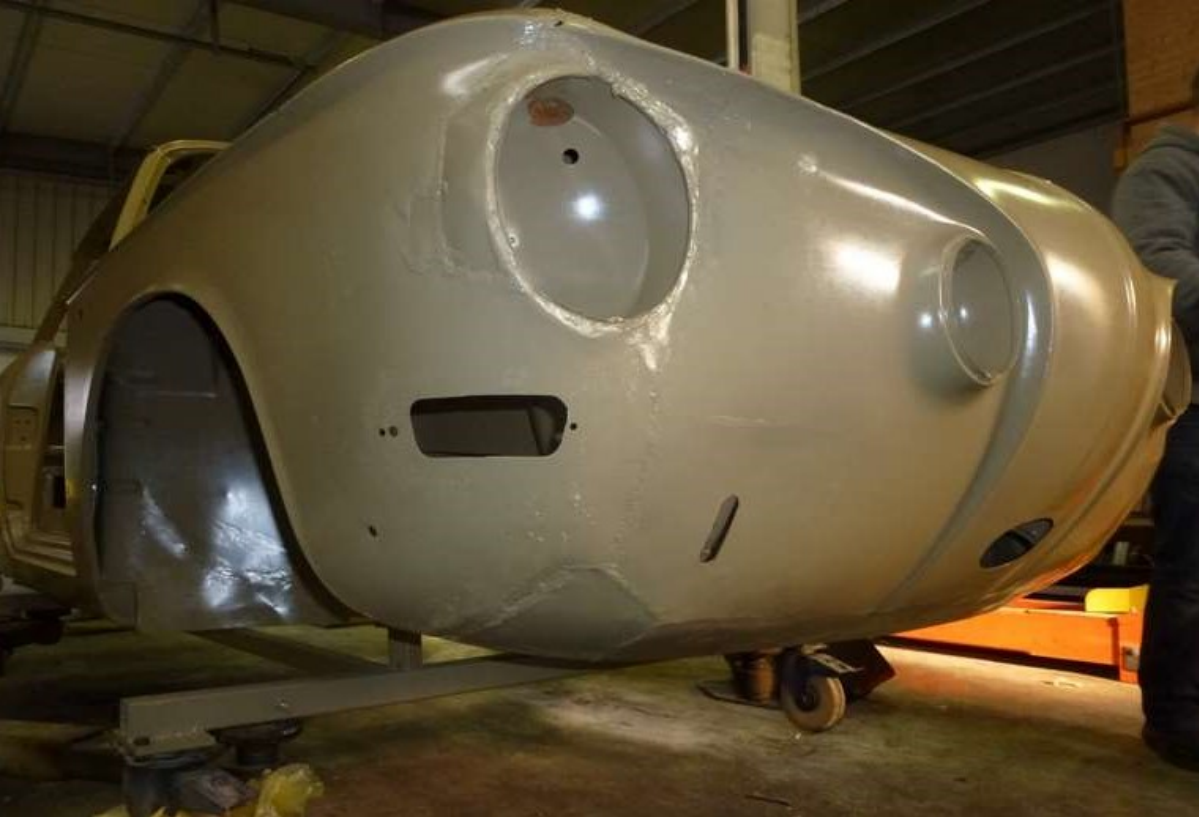
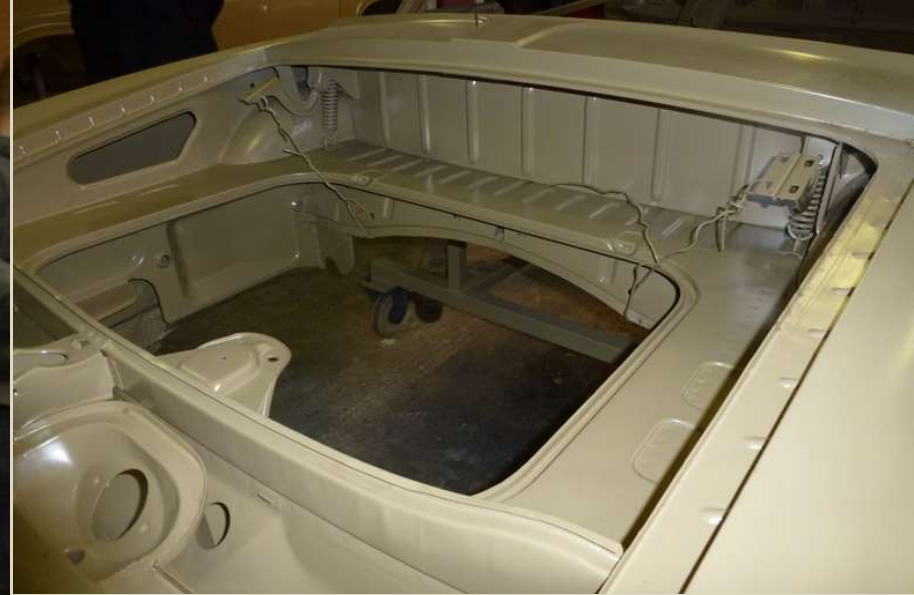
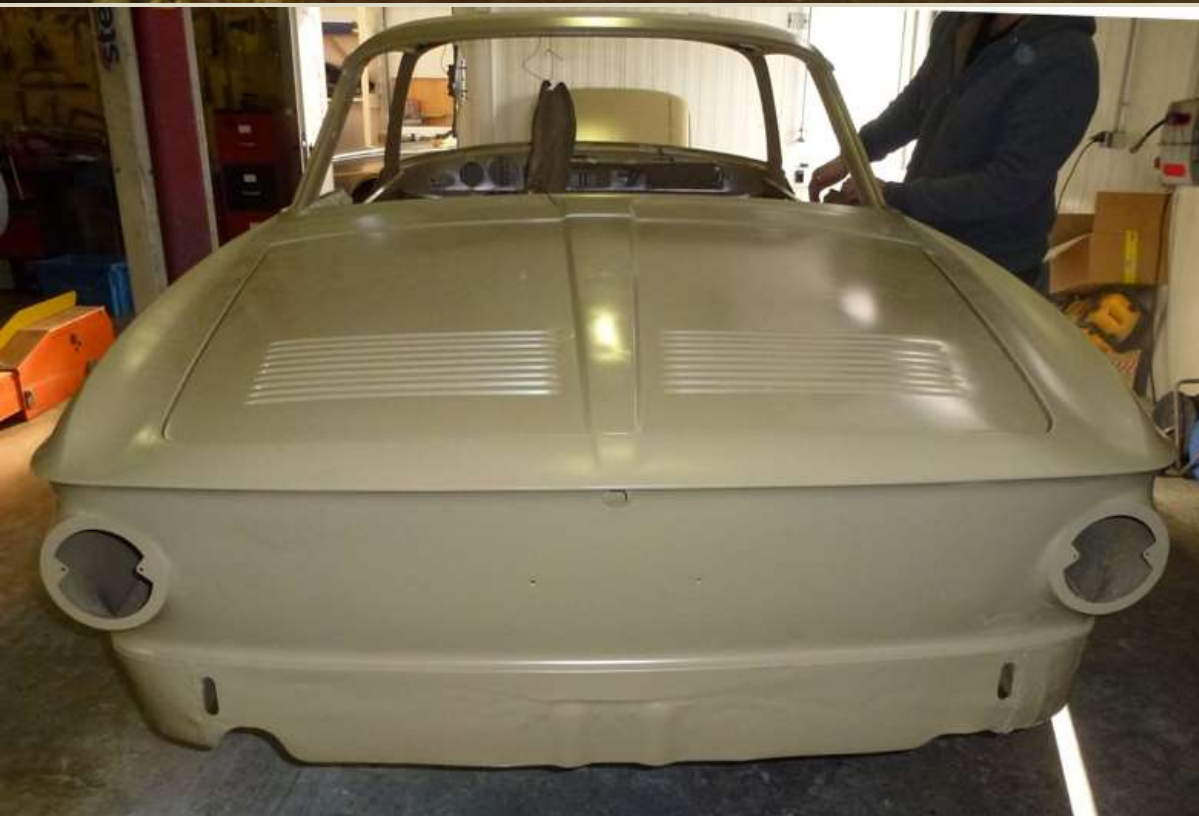
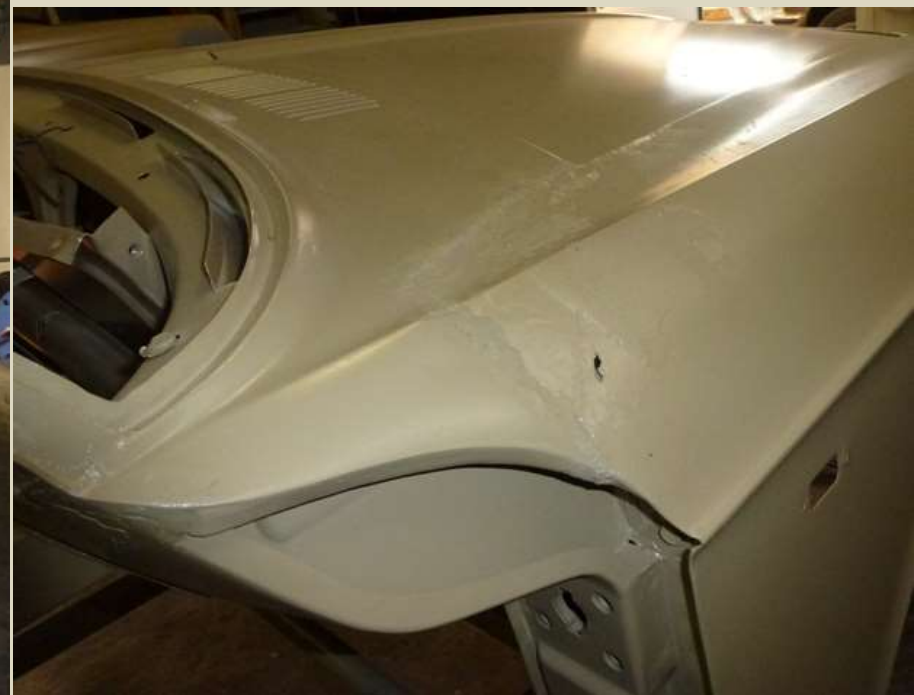
These photos were taken after the triple-series of chemical dipping to remove the paint, rust, & apply the anti-rust coating of primer paint. You can see the original tin, used to join the metal panels at the Karmann factory, has been removed, so these seams will be finished-off next. This dipping process is essential to be confident all of the rust has been removed forever.

“The major welding has been completed on my 1966 T34 and the body now needed to be dipped to remove the rust. After welding, the biggest issue is one of corrosion protection. To avoid any rust developing after the restoration was completed I decided to have the body completely submerged in a three-part process. The first dip is to remove the paint. Then we de-rusted the body in a second acid bath. In this process all of the voids which can't be cleaned manually are taken care of. Then the body is submerged in the third bath which coats it with a protective layer of Cathodic electrophoretic paint. This gets into all of the cavities and protects the body against future corrosion. The photo above is of the initial dipping (showing a Triumph) but I only have photos after the Cathodic electrophoretic paint because the company didn't allow photos in the other dipping rooms. The tin (which joins the steel panels) gets stripped-off after the second bath, so you can see all of the little pin holes. So now we have now small holes in the front which must be welded again, but this is a small amount of work and not a big problem.

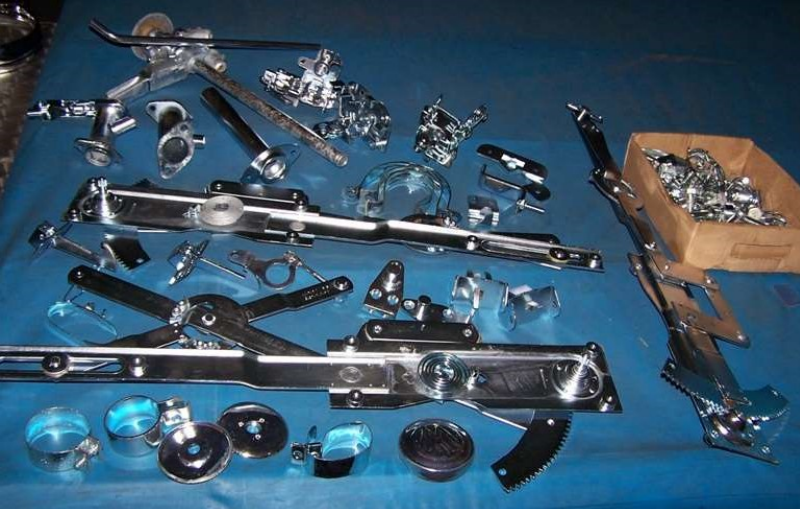
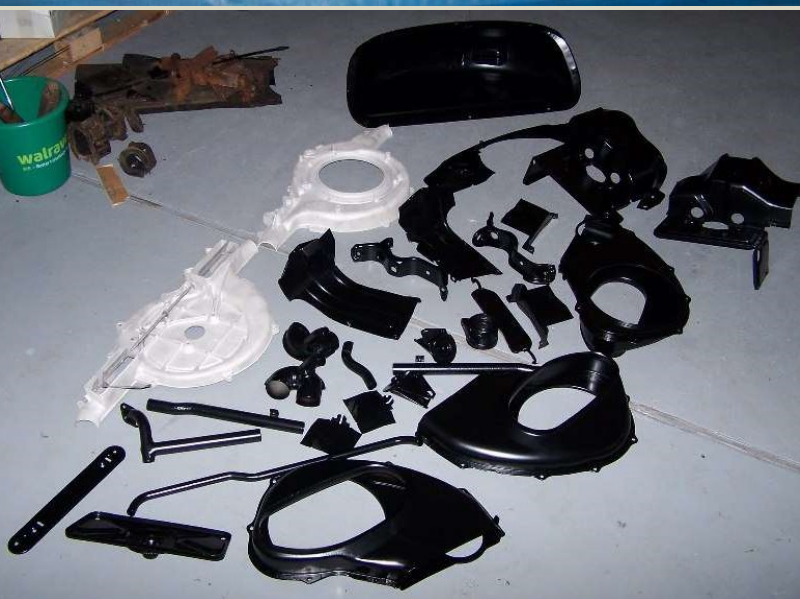
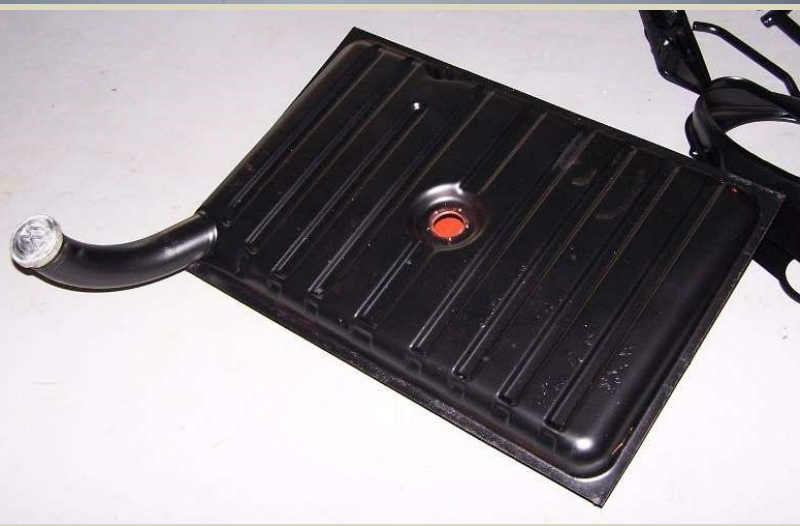
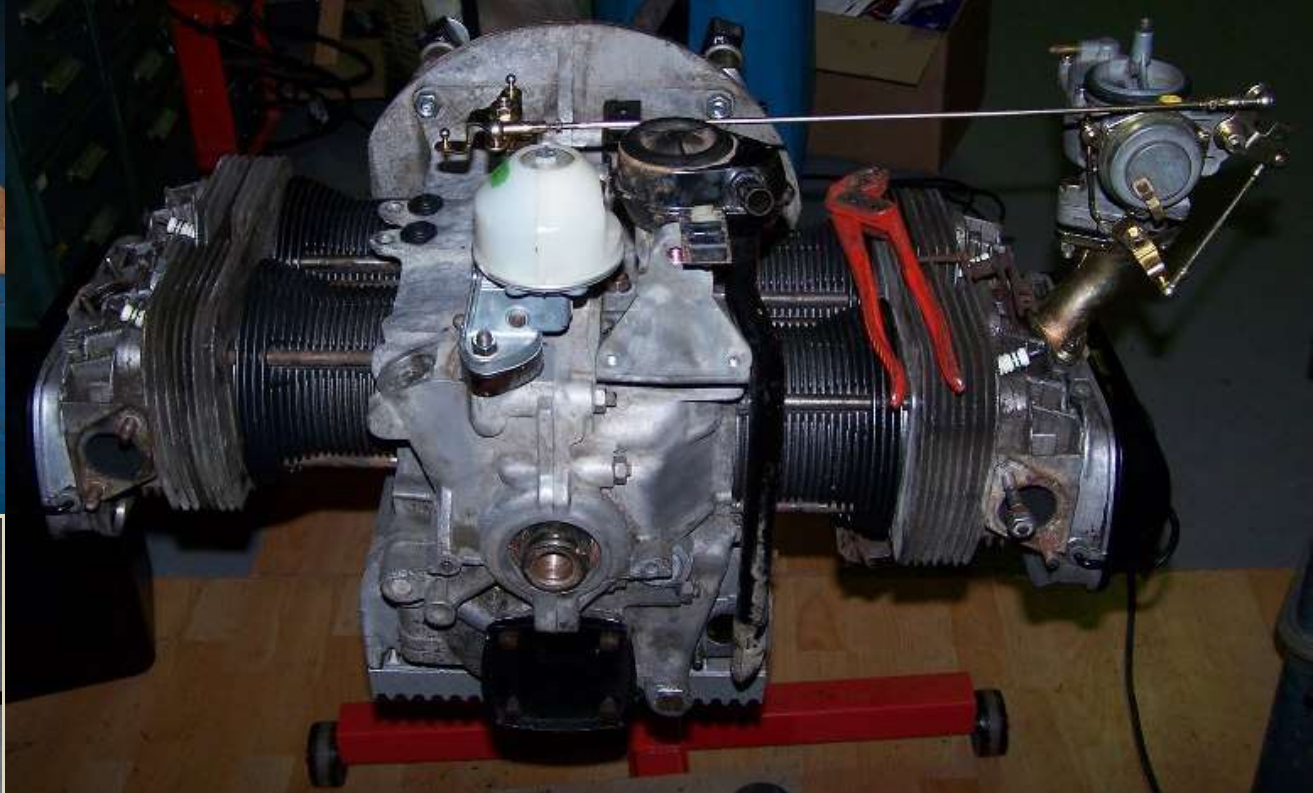
I also had all of the non-chrome metal parts galvanized including the door window regulators, screws, & bolts. Black powder-coating was applied to the engine sheet metal and spare tire carrier. The fuel tank was rusty so it was de-rusted first and then coated with a plastic solution inside. The engine was rebuilt & reassembled. It's nice to see these old parts new once again!"

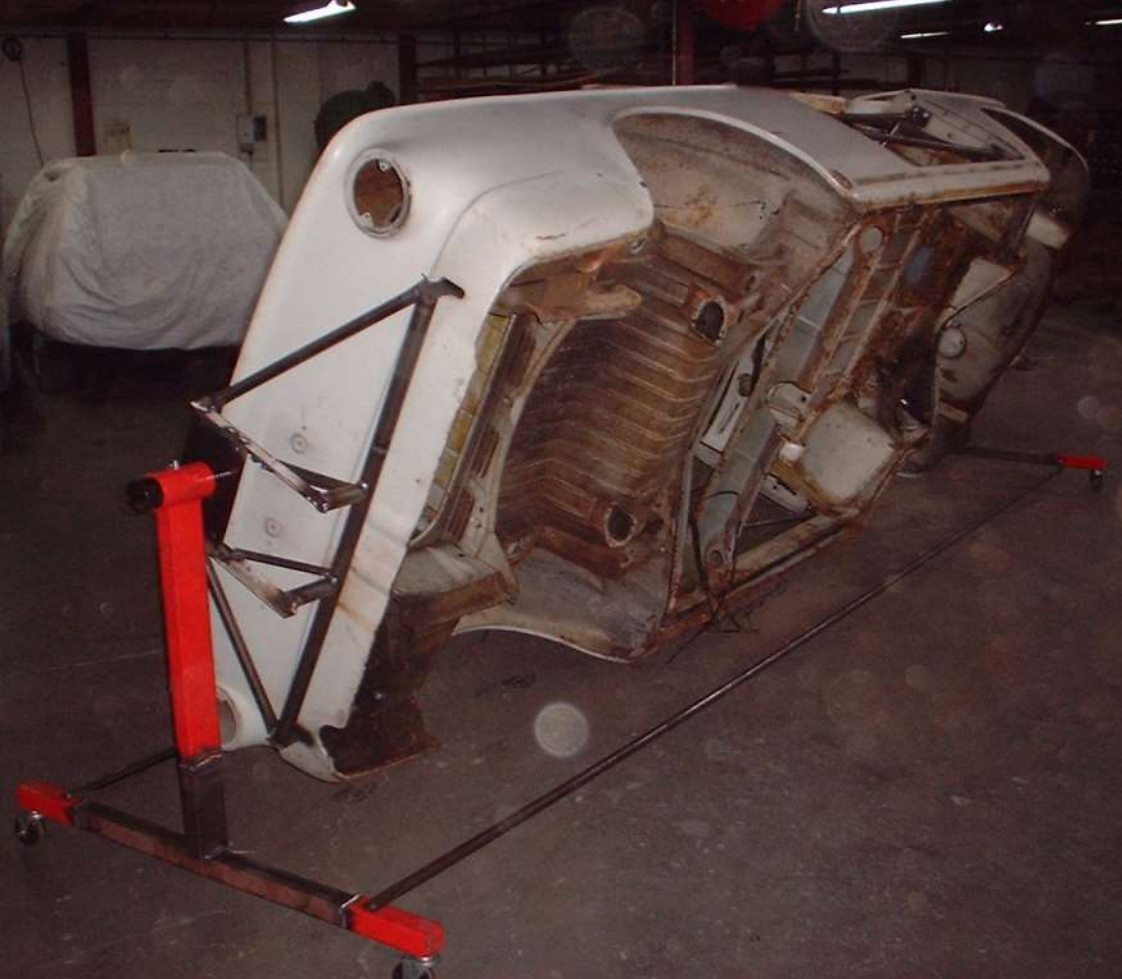
Where to start? I thought replacing the panel above the transmission would be a decent place to start so in order to get at it properly the parcel shelf needed to come out so I got to work drilling spot welds out (below). You can see the heavily rusted C-pillar and the rusty seams between the panels behind the rear seat.
